## Engineering Code 17 Updates

### 95DSS3

Effective 1st of July 2022 all 95DSS3 flame scanners will be shipped with new firmware & new hardware features.

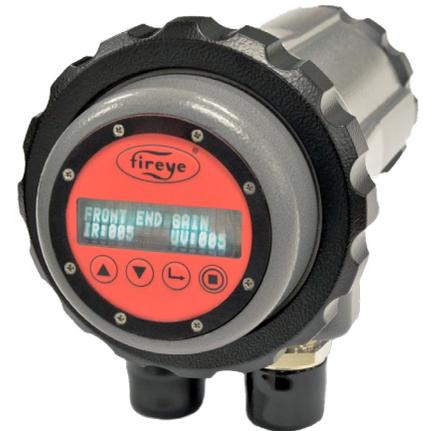
*For example : The figure below shows the selectable ranges in each mode if the scanner were calibrated for a value of 180 for the Standard range of 10.*

Engineering Code 16												Factory Calibration Value	
UV	Selection	Low				Med						High	Factory calibration shall be between 145 and 255
	Value	0				90						180	
IR	Selection	Low	Low+1	Low+2		Med						High	
	Value	0	13	26		90						180	
Engineering Code 17													
Standard	IR	Selection	1	2	3	4	5	6	7	8	9	10	N/A
		Value	0	20	40	60	80	100	120	140	160	180	N/A
Expert	IR	Selection / Value	Range 0 to 180										Range 180 to 255
Standard	UV	Selection	1	2	3	4	5	6	7	8	9	10	N/A
		Value	0	20	40	60	80	100	120	140	160	180	N/A
Expert	UV	Selection / Value	Range 0 to 180										Range 180 to 255

*The tables above shows the relationship between the old & new settings*

- Standard Range (default): A factory calibrated range can be selected between 1 to 10.
- Expert Range<sup>NEW</sup>: The user sets the pre-amplifier directly with a value between 0 & 255.

The scanner will calculate the correct range when switching over from Standard to Expert and vice versa.
